# Tesla Regen, Brakes and Sudden Acceleration

Ronald A. Belt  
Plymouth, MN 55447

1 June 2020

**Abstract:** EDR log data from a Tesla sudden acceleration incident is presented. To explain the EDR data, the operation of Tesla’s drive motor control system and braking system are examined. As expected, friction braking and regen are completely separate with no blending. The braking system, however, includes several vehicle stability control functions that have a profound effect on regen operation in the presence of wheel slip, such as stopping regen when going over bumps and while turning corners. One of these slip control functions can cause the drive motor to speed up if regen is causing slip in the rear drive wheels that can lead to an oversteer or understeer. This same slip control function can be misled by a defective brake light switch to confuse a brake-induced deceleration for a regen-induced deceleration, in which case the harder a driver presses on the brake pedal, the larger a positive motor torque is produced. This is believed to be the cause of sudden acceleration in over 70% of Tesla vehicles.

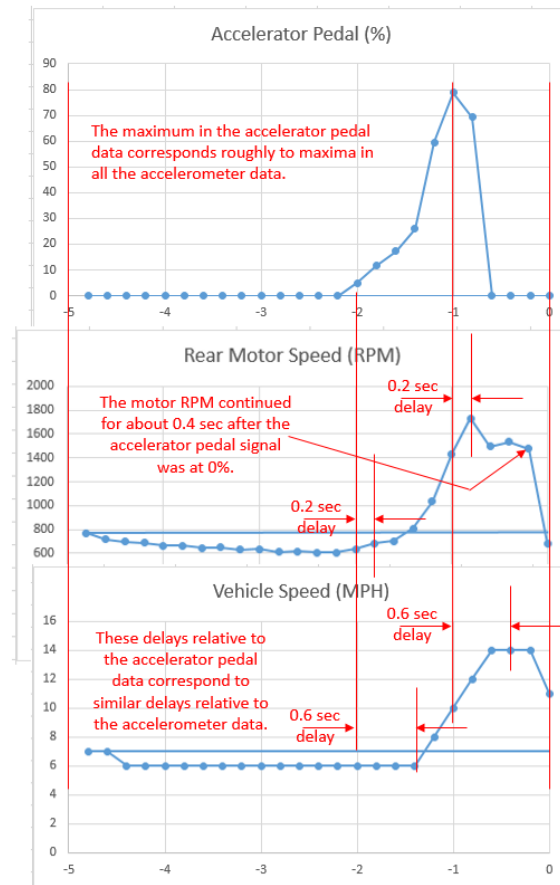
Figure 2 shows the vehicle path during the incident. The street and driveway were both flat and on the same horizontal level. Figure 3 shows the EDR data for the pre-crash values of the accelerator pedal (%), rear motor speed (RPM), and vehicle speed (MPH). The accelerator pedal data shows that a value of 80% was reached one second prior to the crash. The vehicle speed data shows that the speed changed from 6 MPH before the crash to 14 MPH at the time of the crash. These alone might suggest that the driver pressed on the accelerator pedal to cause the crash. However, the pre-crash accelerometer data tell a different story.

Figure 3. EDR data showing pre-crash values of accelerator pedal (%), rear motor speed (RPM), and vehicle speed (MPH)

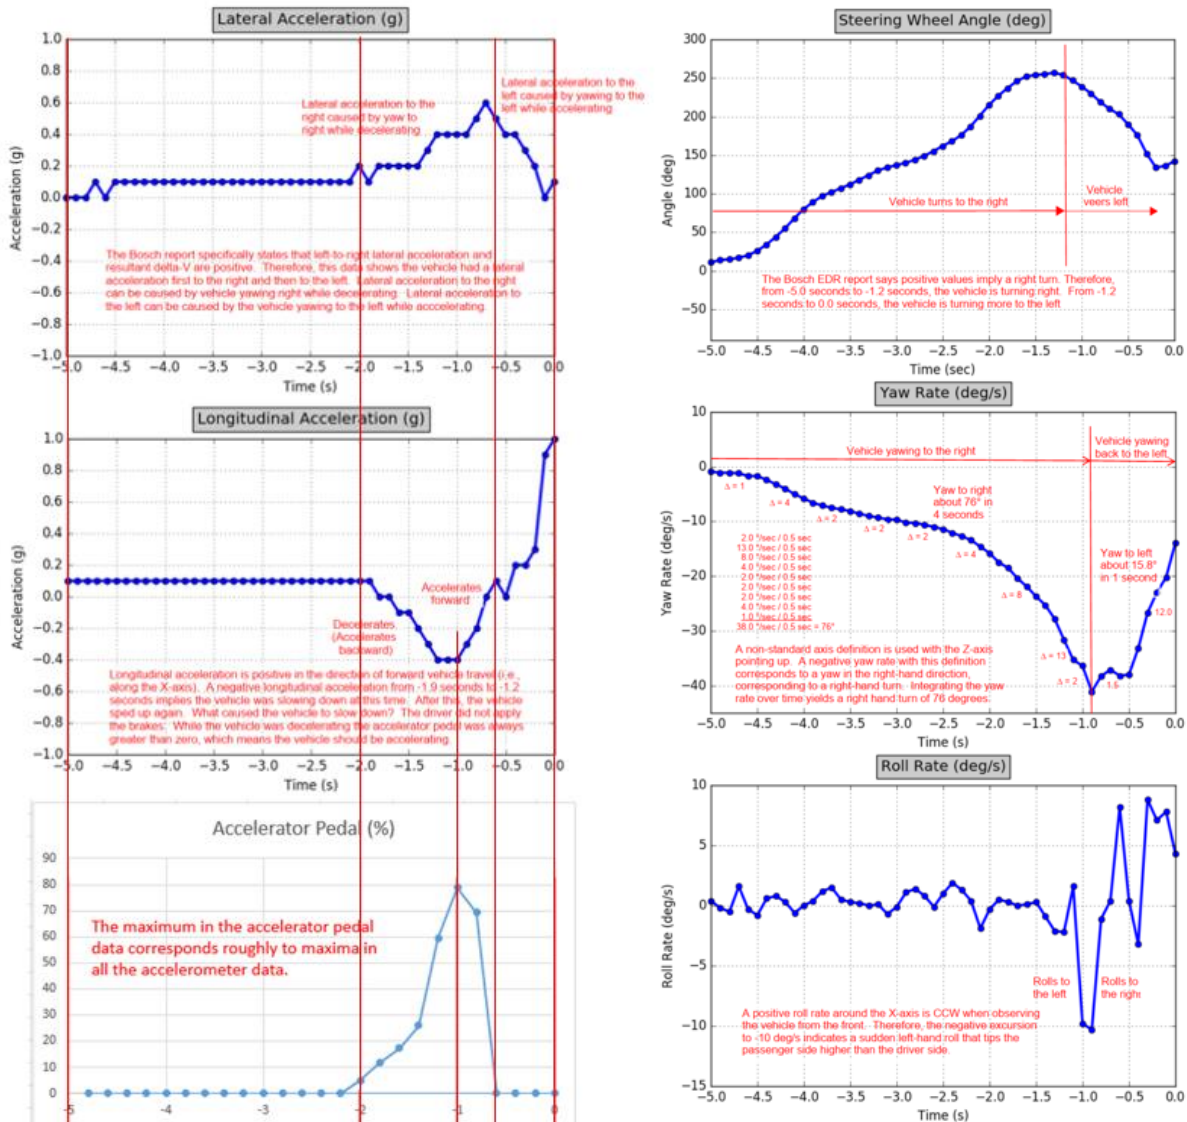
Figure 4 shows the pre-crash accelerometer data. The longitudinal accelerometer data show that the vehicle had a rapid deceleration of  $-0.5\text{ g}$ 's from  $+0.1\text{ g}$  to  $-0.4\text{ g}$  one second before the crash. Since the Model 3's regeneration is limited to  $-0.2\text{ g}$ 's (increased to  $-0.3\text{ g}$ 's by software update 2018.42 v9 on October 25, 2018), this higher  $-0.5\text{ g}$  deceleration could not have been caused by the vehicle's regen system. Instead, it can only have been caused by the vehicle's braking system. This conclusion is supported by the high resolution log data described by Tesla which shows that the brakes were applied even though the EDR data says they were not (Fig 5). Therefore, the driver was pressing on the brake pedal at the time the drive motor revved up, exactly as she described.

Comparison of the accelerator pedal data to the longitudinal acceleration data shows that the increase and decrease in the accelerator pedal data are coincident with the decrease and increase in the longitudinal acceleration data, which is determined by the depression of the brake pedal. This suggests the possibility that the accelerator pedal may have been pressed at

Figure 4. Pre-crash accelerometer data. An ISO 8855 coordinate system is used in which the longitudinal x-axis points forward, the y-axis points to the driver's left, and the z-axis points up. The steering wheel angle is positive when turned to the right.

The longitudinal acceleration data in Figure 4 also shows no evidence that regen is occurring as the vehicle is turning into the driveway before the drive motor revs up. This observation is supported by the vehicle speed data of Figure 3, which shows that the vehicle speed remains constant at 6 MPH before the drive motor revs up. Yet, the driver maintains that the vehicle was in the HOLD mode with STANDARD regen throughout the incident. If the driver is correct, then why isn't regen apparent in the data of these two sensors?

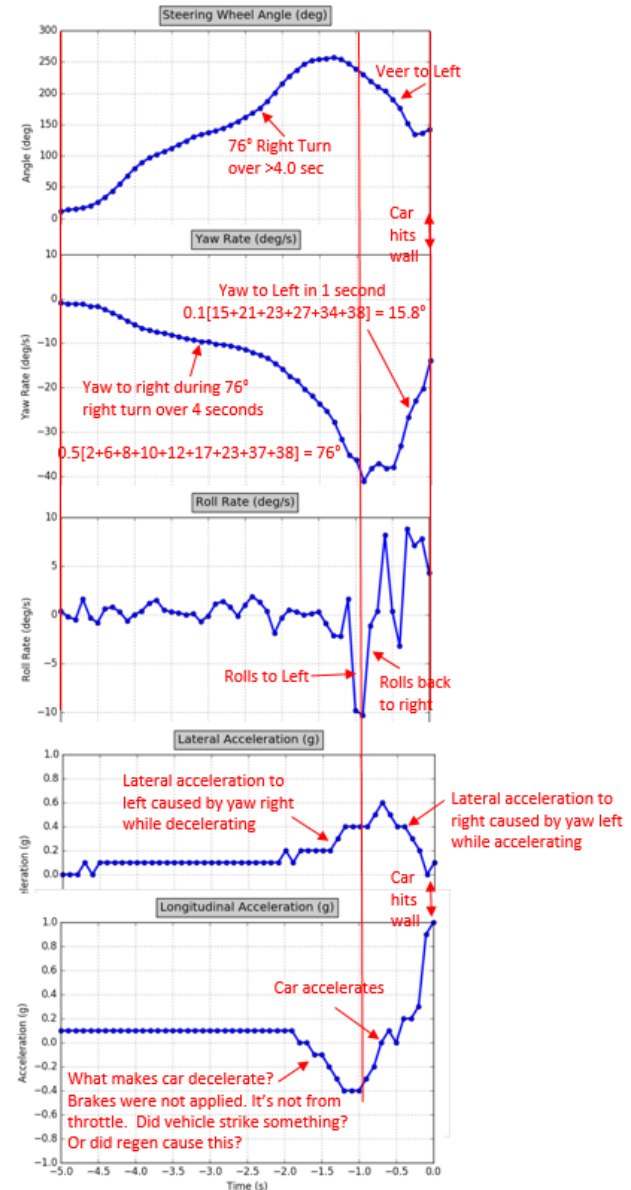
A closer look at the steering wheel angle data and the yaw rate data reveals that the yaw rate is still increasing while the steering wheel angle is leveling off or even decreasing. This suggests that front wheel slip is occurring to cause an oversteer condition, which could activate the

Figure 6. Accelerometer plots aligned in time show that the peaks roughly align at -1.0 seconds

vehicle's stability control system. The normal response of a vehicle stability control system to an oversteer condition is to brake the outside front wheel to cause a yaw moment in the direction opposite to the oversteer direction. In this case, during an oversteer to the right, the left front wheel would be braked, causing the vehicle to yaw to the left. This is exactly what is observed. This appears to explain the driver's testimony that the vehicle "turned to the left" to cause damage to the right front corner of her vehicle.

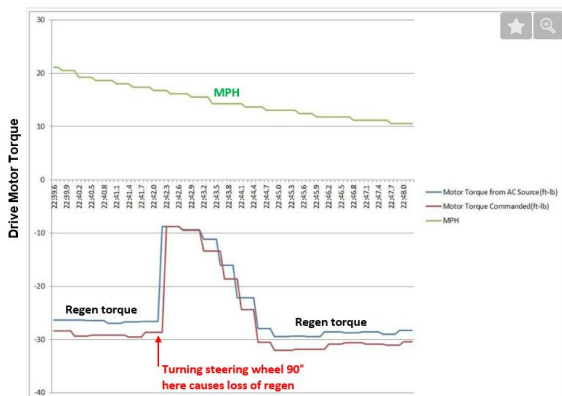
Figure 28. When the steering wheel is turned 90°, regen is lost and a forward surge is felt.<sup>44</sup>

From these two discussions we see that all Tesla vehicles, as well as Ford Fusion hybrid vehicles, can experience a loss of regen while cornering. This loss of regen is caused by the ABS system turning off regen when the wheels on one side of the vehicle have a speed that differs from the wheels on the other side of the vehicle, which happens during cornering.. It is not the result of a design decision made by Tesla, but of the algorithms in the ABS modulator that were designed by Tesla's brake supplier, Bosch. And Bosch designers had no choice but to turn off regen when their algorithms activate, because their algorithms must have control over all the braking forces on the vehicle while the algorithms are active. And, having no control over the regen magnitude, they must shut off regen while their algorithms are active. This is true for all electric vehicles with regen, and not just Tesla for vehicles.

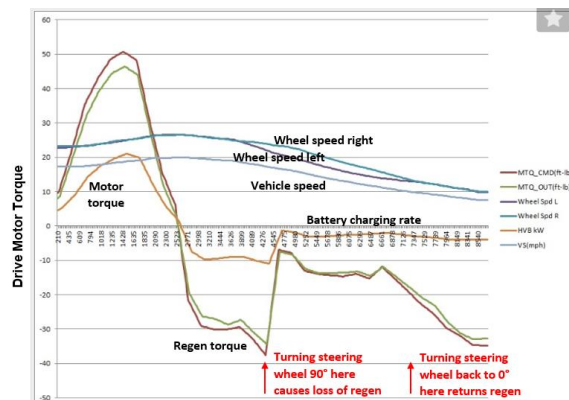
Figure 29. When the steering wheel is turned 90°, the wheel speeds change and regen is lost, causing a forward surge.<sup>44</sup>

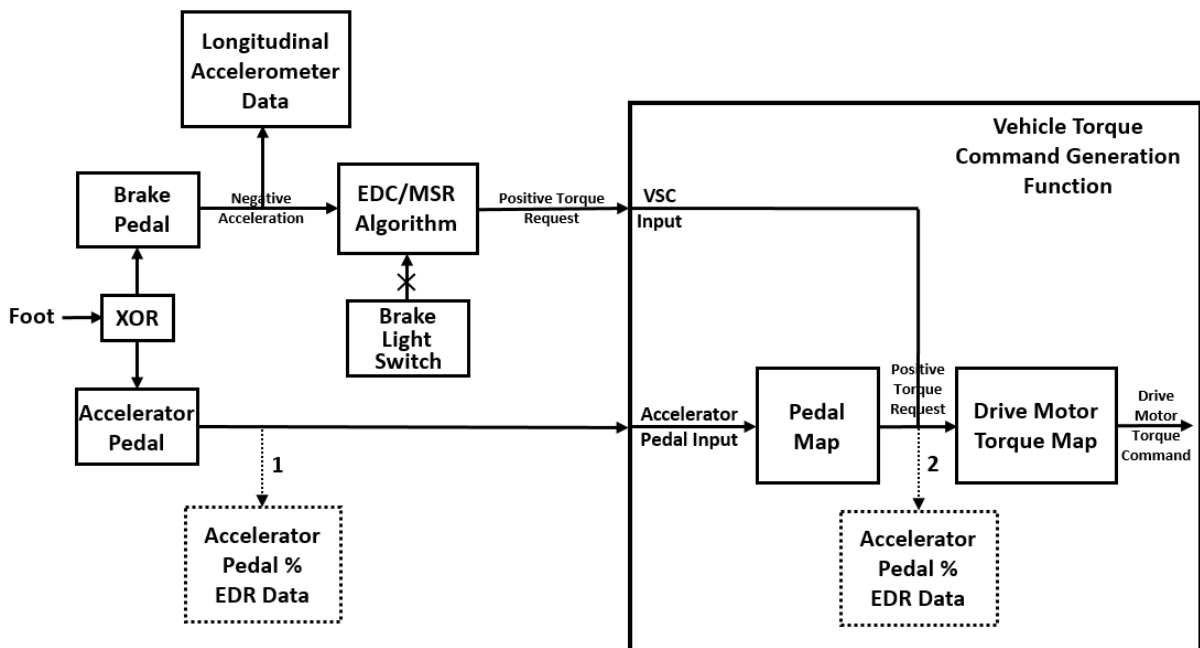
What likely happened in this incident is the brake switch was faulty. As a result, when the driver pressed on the brake pedal to cause a negative acceleration of 0.5 g's, the brake switch did not show that the brake pedal was being pressed. Therefore, when the EDC/MSR function detected the negative acceleration, it checked the brake switch to find the cause and got a false reading showing that the brake pedal was not being applied. As a result, it concluded that the negative 0.5 g acceleration was caused by a regen torque from the drive motor, instead of the brake system as was truly the case. This caused it to send a request to the drive motor to reduce the negative torque by increasing the drive motor torque. Since the drive motor torque was already zero because regen had been cut by the ESP hev II module early in the turn, this request to increase the drive motor torque caused the drive motor torque to increase from 0 to an RPM corresponding to 0.5 g's of positive torque. This is what we see in the longitudinal acceleration data, with a slight time delay of a few hundred milliseconds caused by the command latency over the CAN bus. What has happened in this case is that the faulty brake light switch has caused the brake pedal to behave like an accelerator pedal. The harder the brake pedal is pressed, the more positive drive motor torque is produced.

To answer this question, let's first clarify what was happening in greater detail. Figure 30 shows the sequence of events involved in this incident. The driver's foot could either be on the brake pedal or the accelerator pedal, and not on both at the same time. This explains the exclusive-OR (XOR) function in Figure 30. Pressing on the brake pedal produced a negative acceleration of 0.5 g's which was recorded by the longitudinal accelerometer. The EDC/MSR algorithm in the brake modulator also detected this negative acceleration, and after checking the defective brake light switch, it interpreted the negative acceleration as a drive motor drag torque. Therefore, it issued a request to the drive motor for a positive motor torque to offset the negative drag torque. This request went via a CAN bus to the VSC input of the Vehicle Torque Command Generation Function in the drive motor control system (Figure 16), where it became a positive torque request to the drive motor torque map.

Figure 30. Sequence of events involved in this incident

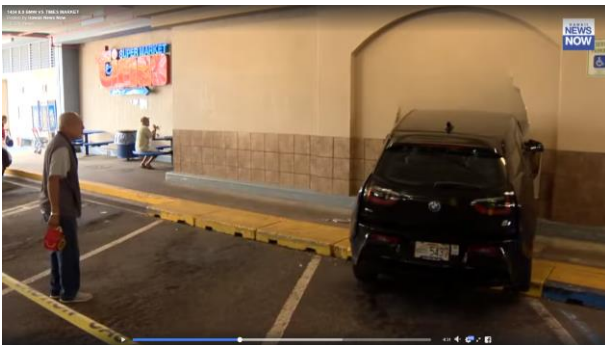
Figures 31 and 32 show a BMW i3 that has run into a wall.<sup>47</sup> This incident took place in the Kiamuki Shopping Center in an inner suburb of Honolulu on August 11, 2019. Although no driver's testimony is provided about the incident, it is clear from the photos what happened. The driver was trying to park in a perpendicular parking space in preparation for shopping in the Times supermarket. The parking space was near the entrance of the supermarket. As the driver was pulling into the parking space after making a 90° turn, the vehicle's drive motor revved up. The BMW i3 has a single rear drive motor just like many Tesla's. This incident is exactly like the 70 Tesla sudden acceleration incidents of Category A in Section 9, for which our explanation is valid.

Figure 31. BMW i3 after suddenly accelerating while pulling into a perpendicular parking space.<sup>47</sup>

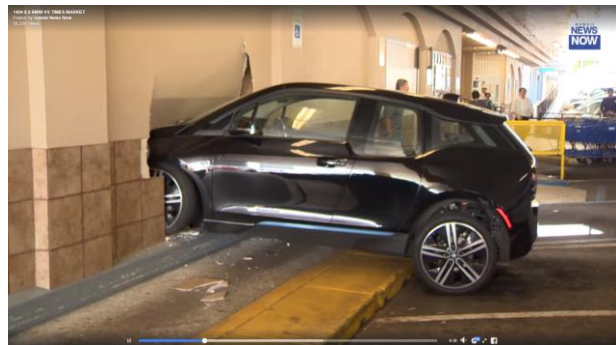
Figure 32. Side view showing damage to the wall behind the parking space. Store entrance is in the background.<sup>47</sup>
